PRODUCT CHANGE NOTIFICATION

DIN Rail Bracket Replacement

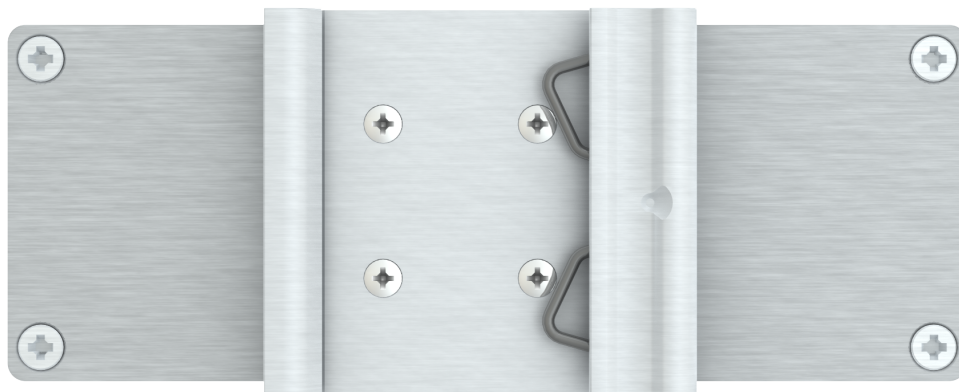
Figure 1: BB-SBD45 DIN Bracket on v2 Router

Detailed Description of the Impact: The replacement, BB-SBD45 DIN rail mounting bracket, is 5 mm higher than the original one. For this reason, the bracket exceeds the rear panel of the v2 router by 2.5 mm, see Figure 1.

Detailed Description of the Issue: Due to the supply shortage of the BB-SBD40 DIN rail mounting bracket, caused by international transport paralyzed with the worldwide pandemic, the bracket will be temporarily replaced with BB-SBD45 bracket.

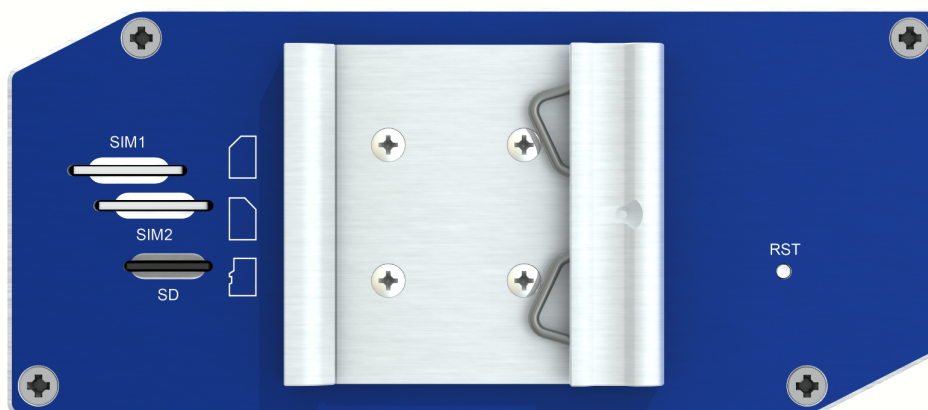
Figure 2: BB-SBD45 DIN Bracket on SmartFlex Router

The BB-SBD45 DIN rail mounting bracket, mounted on a v3 router, is displayed on Figure 2.
